The Locomotive

THE HARTFORD STEAM BOILER INSPECTION AND INSURANCE CO.

VOL. XXXVI.

INDEX TO VOL. XXXVI.—1926-1927

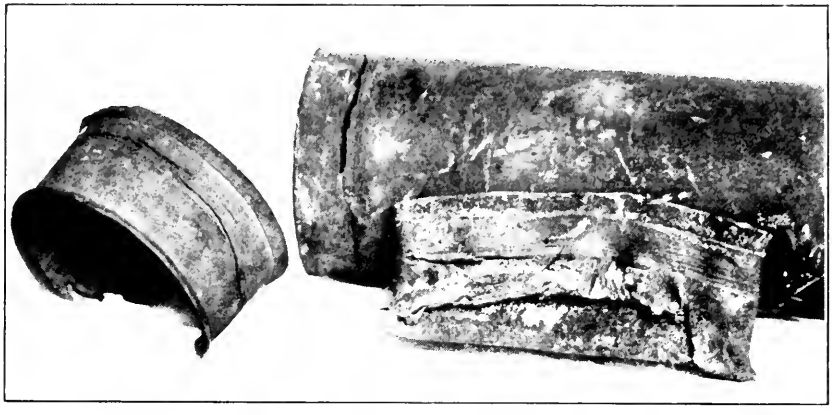
different laboratories, after independent analyses, agreed that the metal was up to the A. S. M. E. standard and had not been injured either in manufacture or when the tube ends were belled over. However, a microscopic investigation of the cracks themselves gave a clue to the true cause, for the fissures followed the borders of the grain — a condition typical of caustic embrittlement. Figure 2 shows the nature of the failure in the tube ends.

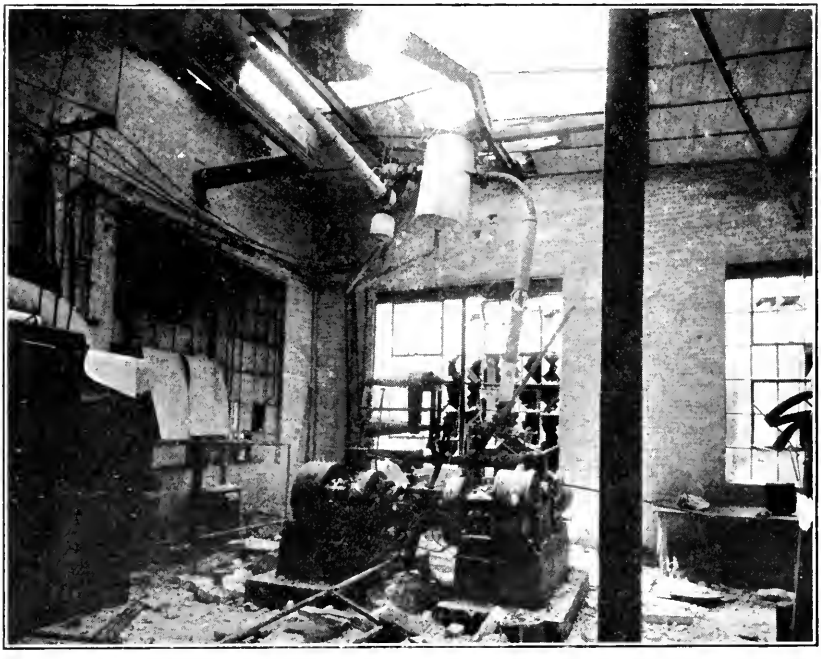
The first indication of trouble was the sudden stopping of the paper-making machine. A few seconds afterward there was a tremendous crash in the engine room as the flywheel went to pieces. From this fact as well as from the appearance of the parts after the accident it seems evident that the main driving belt either broke or ran off the pulley, and that as it did so it whipped around and struck the governor and emergency stop, rendering both of these devices useless. Thus freed of its load and with the throttle wide open, the engine needed but very few seconds to speed up sufficiently to burst the flywheel.
